Effectiveness of the GAEC standard of cross compliance *retain terraces* on soil erosion control

Paolo Bazzoffi,¹ Lorenzo Gardin²

Abstract

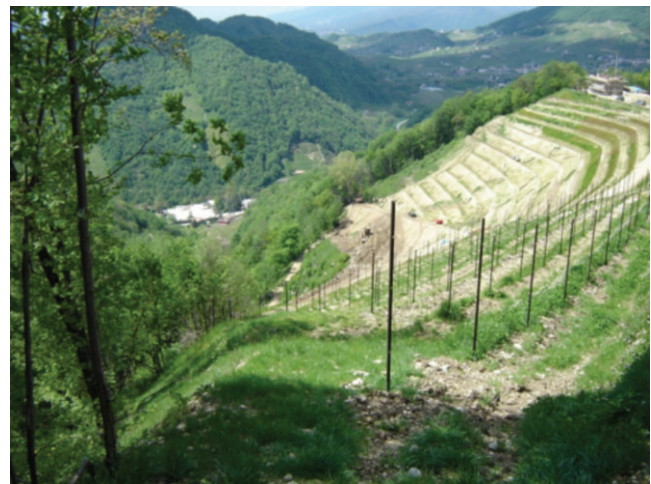
Figure 1. Earth terraces under construction in Veneto (in the Prosecco wine area).

Nowadays, most of the terraced areas are subject to increasing degradation. This is because the labour, the *instrument* that for centuries has provided for their continuous monitoring and maintenance, is too expensive when compared to the gains that can be obtained in the sloping areas characterized by marginal economy. An exception is the sloped areas of high economic interest, especially those of particular value for viticulture and other specialized cultures, where the terraces are preserved and extended up to very high altitudes (Figure 1).

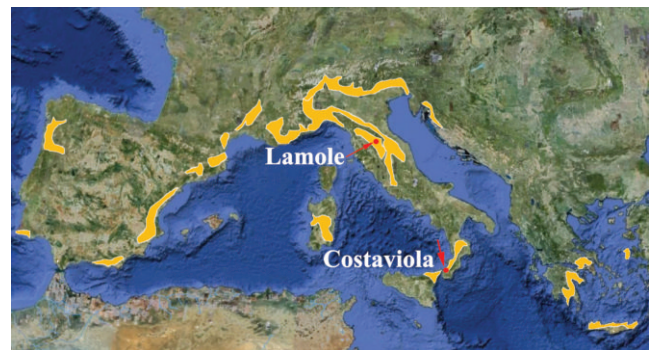
Figure 2. Terraced land in Europe (in yellow) and location of the two study areas, Lamole (Tuscany) and Costaviola (Calabria).

In Europe the areas where terraces are present, especially along the Mediterranean coast, are characterized by very pronounced gradients (King *et al.*, 2000) (Figure 2).

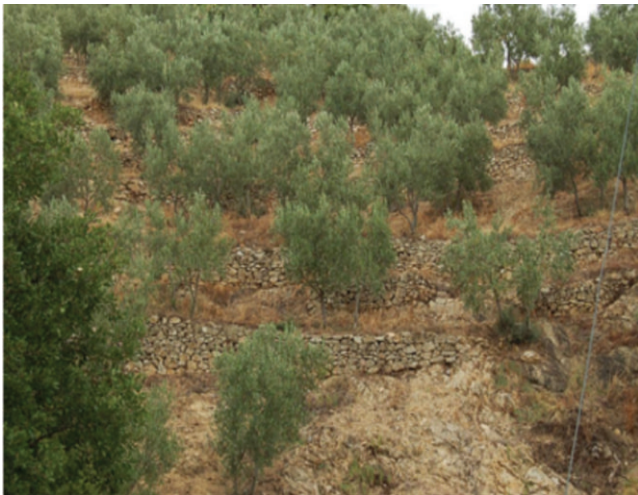
Figure 3. Stone wall terraces (Calabria).

Figures 3 and 4 shows two examples of terraces in Italy to which the standard retain terraces is addressed.

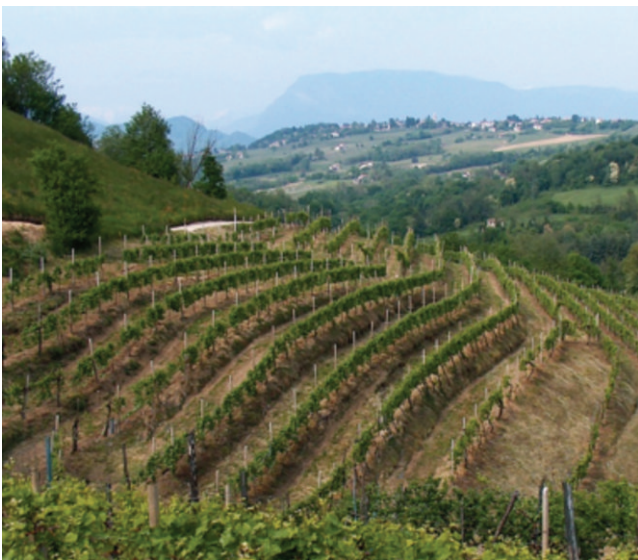
Figure 4. Earth terraces (Veneto).

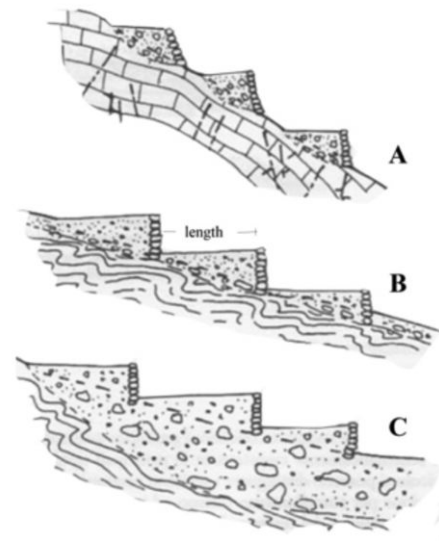
Figure 5. A), terraces set up on compact and permeable bedrock with low risk of landslides; B), terraces set up on eluvial-colluvial deposits with moderate risk of landslides; C), terraces set up on incoherent materials, with high risk of landslide (from Brandolini and Ramella, 1998, modified).

One of the most interesting studies in the Italian territory was carried out in Liguria by Brandolini and Ramella (1998), who compared different types of landslides occurred on terraced lands characterized by contrasting morphological conditions, geological substratum and soil use. These authors grouped agricultural terraces into three main typologies (Figure 5): A) terraces set up on compact and permeable bedrock (cracked) with low risk of landslides; B) terraces set up on eluvial-colluvial deposits with moderate risk of landslides; C) Terraces set

up on incoherent materials with high risk of landslide. This classification can help to understand that degradation of terraces can assume a very wide variety of forms ranging from a quick degradation to no degradation and with different dynamics, depending on site specific condition: climate, geology, morphology, seismicity, land use and management etc.. The most dangerous menace to terraces integrity due to abandonment of their maintenance by farmers is the loss of channel connectivity and, consequently, the loss of runoff regulation. This can lead to mass movement of the soil embanked by terraces. These movements, although very feeble, determine the loss of compaction of the stone walls or cliffs of terraces. Thus, in the presence of extreme rainfall events, the wall can collapse and severe landslides can occur. In general, when stone wall terraces are built on outcropping bedrock they last longer after abandonment of agriculture than other typology of terraces and maintain their effectiveness in controlling runoff water (Figures 6, 7 and 8). In very favorable conditions stone wall terraces, although abandoned, do not alter at all (Figure 6). In Terraces set up on incoherent materials the stones collapsed out of the wall usually

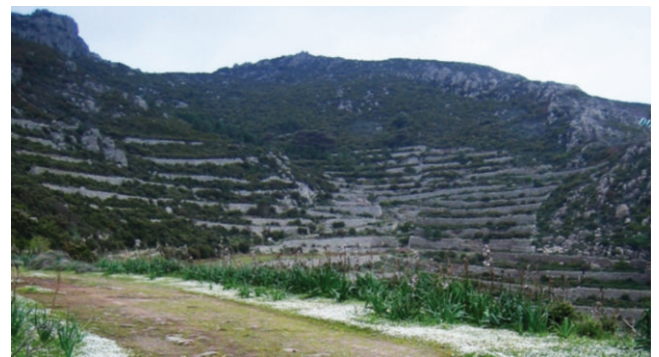
Figure 6. Stonewall terraces set up on compact bedrock at Capraia isle (Tyrrhenian sea) with shrubs and forest in evolution. Terraces were built by prisoners before the dismissing of the penitentiary. In this case the abandonment of agriculture did not lead to degradation of terraces. (Image by Andrea Gervasoni, 2009).

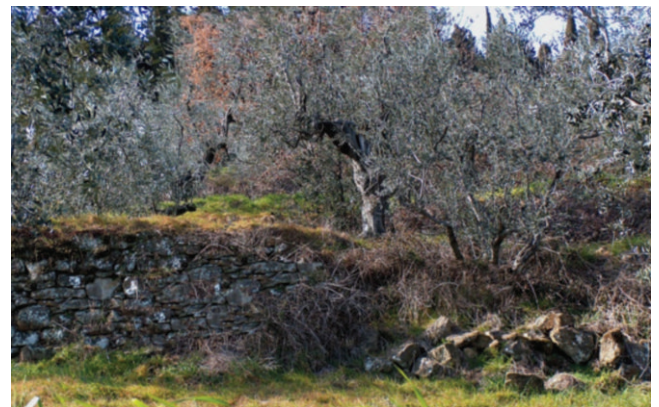
Figure 7. Stone wall terraces set up on incoherent colluvium (Fiesole, Tuscany). Agriculture is almost abandoned and degradation of terraces is going on, but the slope gradient of terraces is still sufficiently conserved.

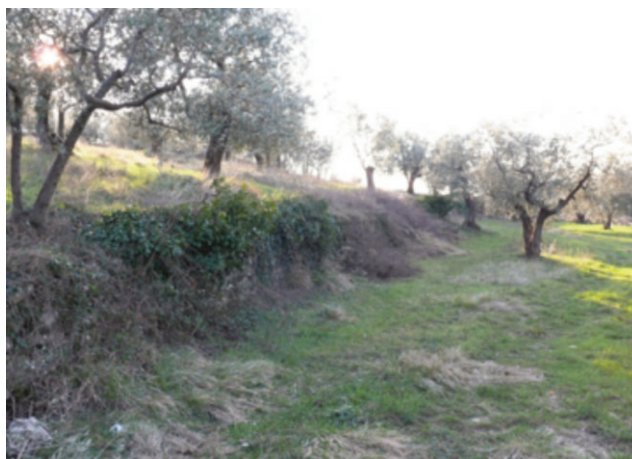
Figure 8. Example of a stone wall almost totally collapsed. Although they are degraded, terraces still maintain a residual function on soil erosion control (Prato, Tuscany).

In the majority of cases, the abandonment of terraces does not lead, in the short run, to a complete draw back of the slope to the antecedent morphology. The local gradient in the correspondence of plans of degraded terraces almost always remains lower than the average gradient of the slope (Figures 8, 9 and 10).

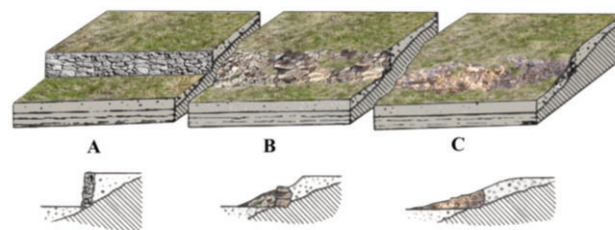
Figure 9. Progressive degradation of stone wall terraces. (A) conserved; (B) damaged; (C) eliminated.

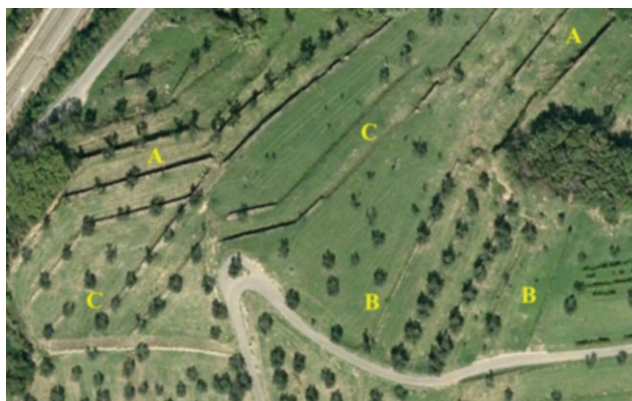
Figure 10. Aerial picture of different levels of terrace degradation according to the schematic drawing of Figure 9 (Prato, Tuscany).

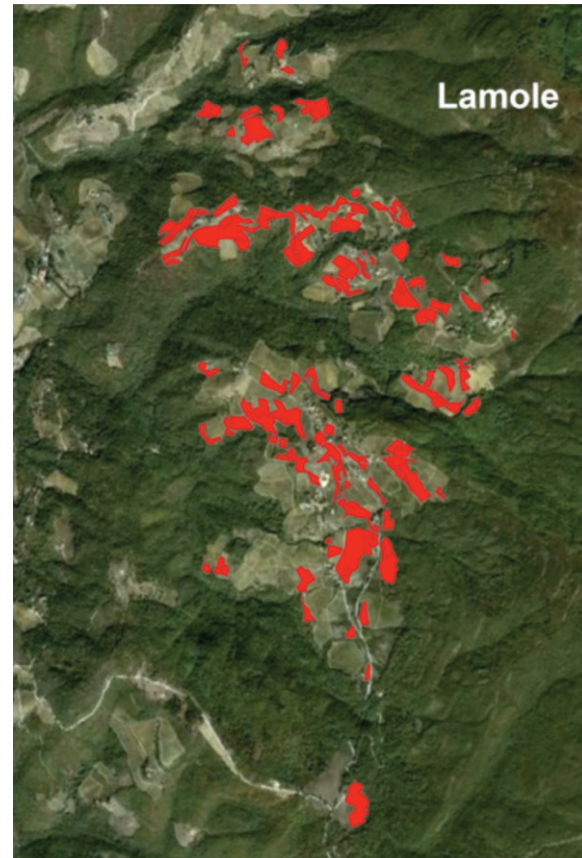
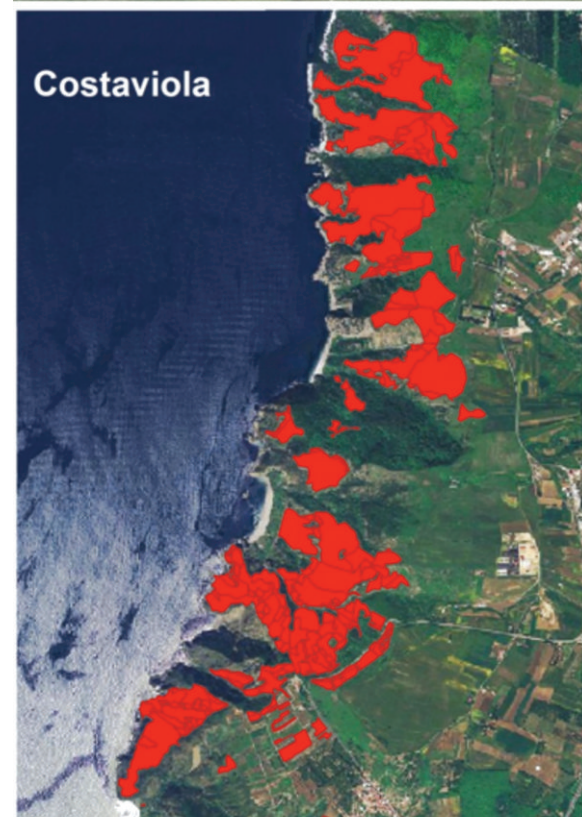
Figure 11. Terraced land (in red) in the two study areas.

The study concerned two sample areas with very contrasting soils, climatic conditions and cultural systems. Both areas are located in landscapes of very high historical and cultural value, forming significant parts of the catalog of *Rural Historic Landscapes* (Agnoletti, 2010) established by the Italian Ministry of Agricultural, Food and Forestry Policies (Figures 11, 12 and 13).

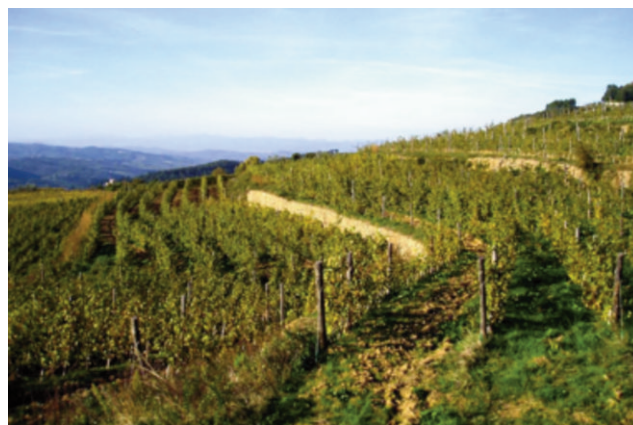
Figure 12. Terraces in the Lamole study area.

The sample area at *Lamole* is located in the famous Chianti vine area (Greve, Province of Florence). The area covers 700.82 ha, with an altitude of about 580 m above sea level. The average slope of terraced land is 29.7%. The geological substratum of the Lamole area mainly consists of quartz turbidite sandstones (42%), feldspar (27%) and calcite (7%), phyllosilicates (24%) and silty shale, and marl in the south are yellow of Oligocene source, named Marne San Polo.

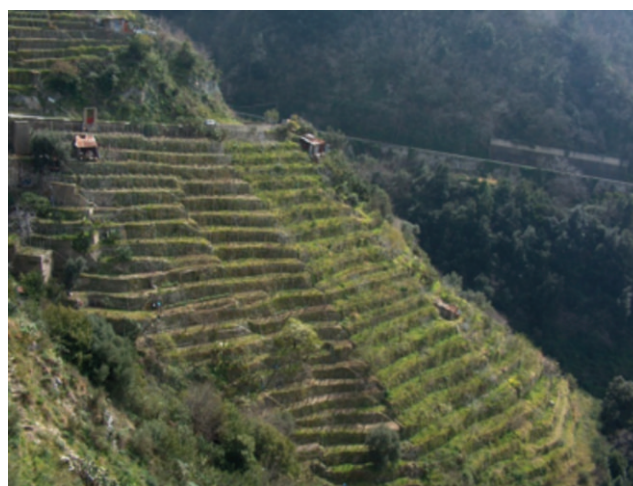
Figure 13. Terraces in the Costaviola study area.

The *Costaviola* area (in the province of Reggio Calabria) is located on the Tyrrhenian coast of Calabria, in the municipalities of Palmi, Bagnara and Seminara, in the Province of Reggio Calabria. The area is almost entirely within the Costa Viola ZPS (Special Protection Area) and belongs to the SIC (Site of Community Importance) named Monte S. Elia. The *Costaviola* study area is private land mostly located at altitudes ranging between 0 and 500 m above sea level. The average slope of terraced land is 59.8%. This area is characterized by the longevity of some old vines cultivated as high pergolas or small tree. Even today, due to the high steepness of the land, the transport of grapes is made through picturesque monorail suspended in the air. The area, extending to 764.73 ha, is located on a geological substrate (mainly amphibole and mica schist with pegmatite veins and jalomicite), while inland areas have a substrate made of reddish clay sand and pebble conglomerates of crystalline sand-clay cement.

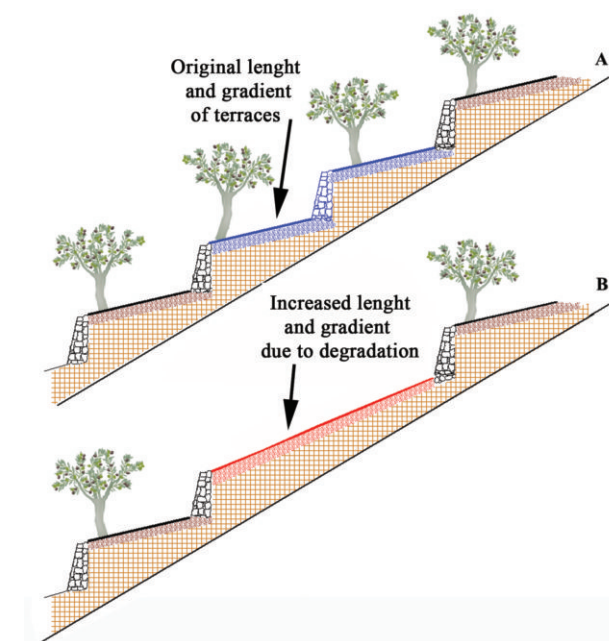
Figure 14. Schematic drawing of minimum and maximum degradation of terraces. A) 0% degradation (conserved terraces). B) 100% degradation (annulment of one every two stonewalls).

In Figure 14 a schematic drawing of minimum and maximum degradation is shown. In the scenario analysis (soil erosion risk vs. intensities of degradation), the length of the hydrological unit was increased by using the following formula:

The gradient (G_i) of the hydrological unit varies in a range between the original gradient of a conserved terrace and the gradient obtained by deleting a terrace every two, as shown in Figure 14.

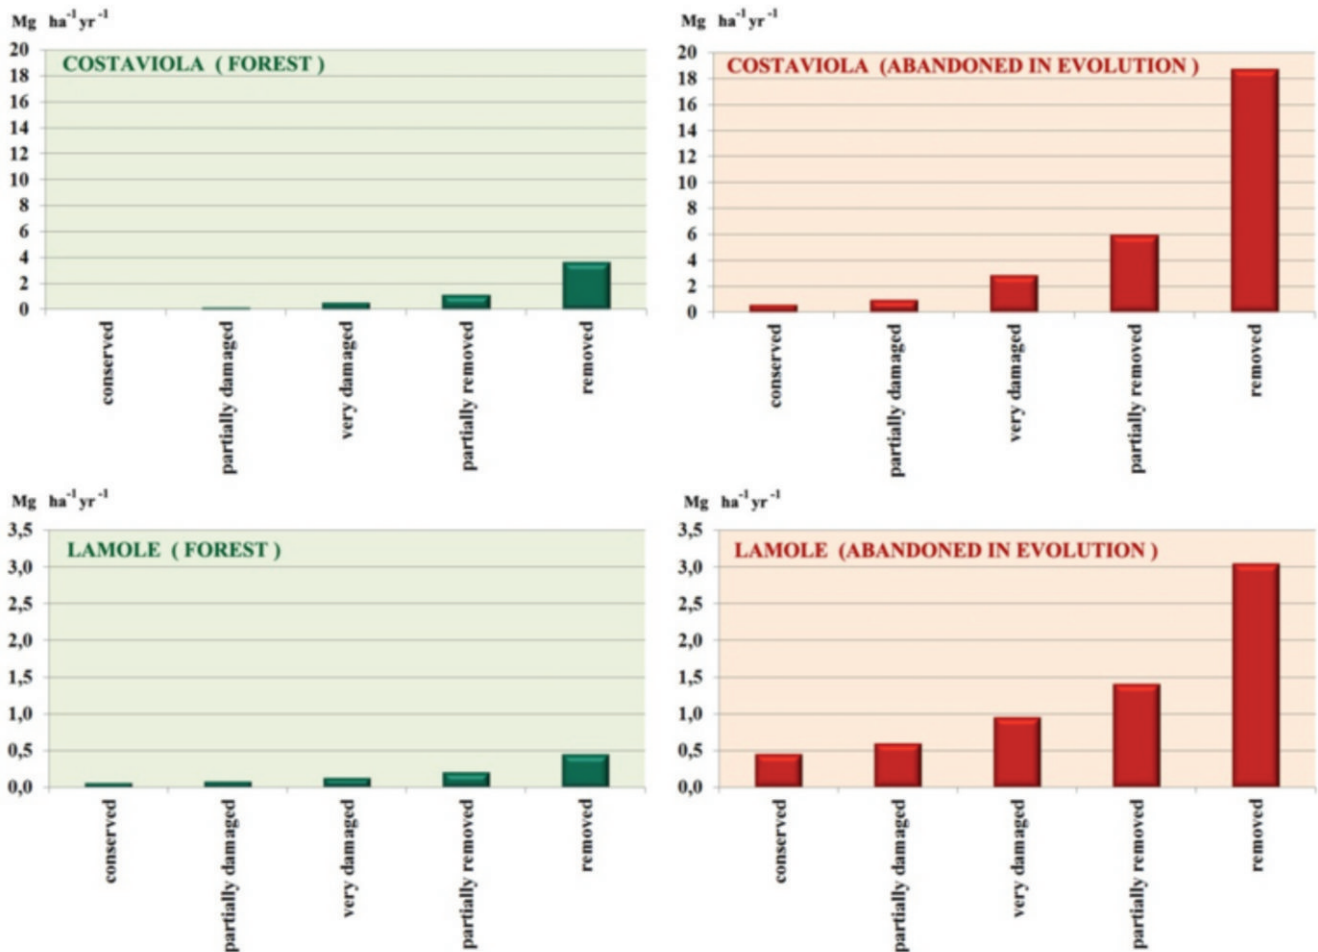
Figure 15. Soil erosion risk for the soil uses: *forest and abandoned areas with natural vegetation in evolution*, according to different levels of terrace degradation in the two study areas.

Figure 15 only examines the results obtained for the land uses: i) *forest* and ii) *abandoned areas with natural vegetation in evolution*. In both areas, the scenario analysis shows that forest on totally degraded terraces is able to decrease erosion well below the tolerance threshold of $11.2 Mg \cdot ha^{-1} \cdot yr^{-1}$, in the same manner as conserved terraces do for other soil uses. At *Lamole*, the natural vegetation in evolution on completely degraded terraces is able to decrease erosion below the tolerance threshold. On the contrary, at *Costaviola*, on the same soil use and level of terrace degradation, soil erosion remains above the tolerance threshold. This difference can be explained by considering that the average natural gradient (the slope considered without the presence of terraces) of areas with natural vegetation in evolution is 71.8 % for *Costaviola* and 29.6% for *Lamole*. Based on these findings, it is possible to argue that terraces, although degraded, continue to play a

role in the protection of soil against erosion in abandoned areas. Thus, they continue to exert a valuable environmental function in terms of production of *public goods and services*; in particular, in the decrease of hydrogeological risk.
